# Manhole Inspection Summary

Manhole # S13II1037MH

Insp Date: **2/9/08 8:48 AM**

**Location** Address: **4400 PIMLICO RD**

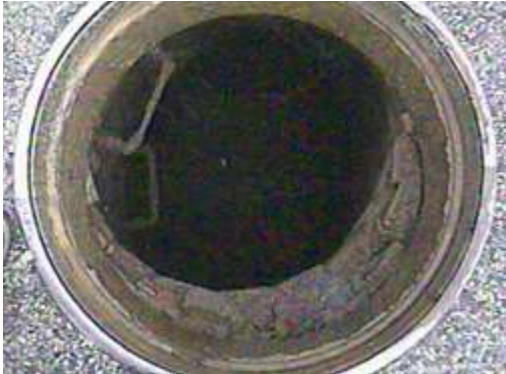
Defect 1

Condition: ☐ Sound ☐ Cracked ☐ Root Intrusion ☒ **Loose Brick** ☐ Deteriorated

loose bricks at frame adjustment and offset frame

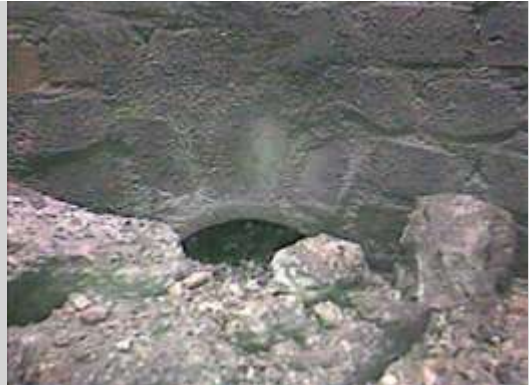
12 O'Clock Outflow

8 in. Circular Gravity Sewer  
Pipe Out @ 12 O'Clock

Deposits: ☐ None ☒ **Mud** ☐ Sludge ☐ Debris ☐ Grease

Silt Depth: **8** (in.) Deposits Extent: **Heavy**
